This document provides basic information about the lot at 104 Campbell Lane, the access roads to it, and the Campbell Cove Development.

Development Lot: E-1

Deering Tax Map: 229, Tax ID: 229-20

Address: 104 Campbell Lane, Deering NH 03244

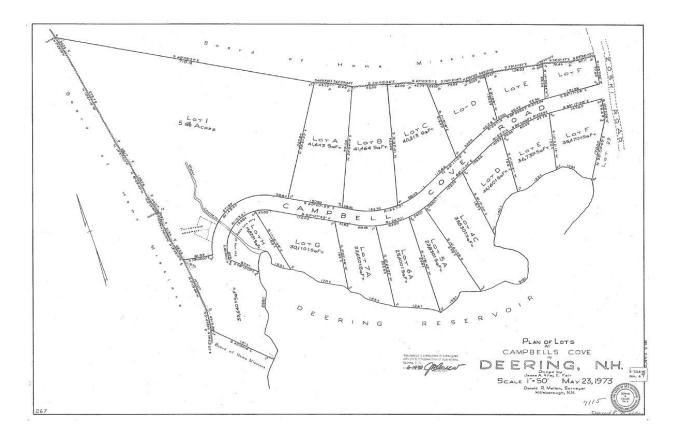
"Plan of Lots at Campbell's Cove in Deering, NH"

Above is the development plan. 104 Campbell Lane is Lot E.

Dated May 23, 1973 & Approved by Town of Deering 6/14/1973

Filed at Hillsborough County NH Registry of Deeds as Plan #7115

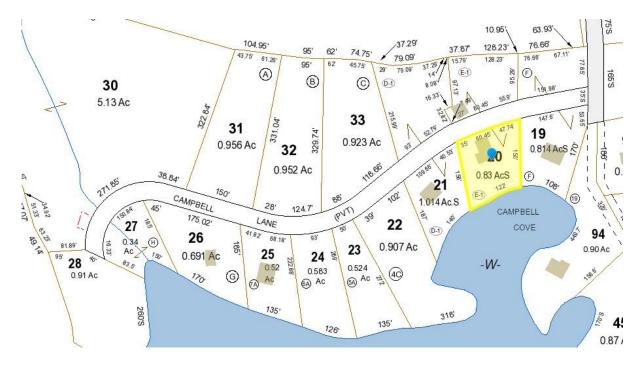
The following figure, showing most of the development, was extracted from the town's current tax map on the GIS (Graphic Information System). It shows the current tax numbers for the lots, all of which are prefixed by "229" (For tax map 229). Lot 20 is 104 Campbell Lane, and has tax number 229-20. It is identified as subdivision lot E-1.

Lots 19, 20, and 21 are split into two sections by the private "Campbell Lane".

A minor brook drains the land north of the development. From Lot 30, it crosses Campbell Lane through a large culvert at Lot 27, as is shown on the map.

Street addresses are not shown but run as even numbers from 102 (for lot 19) to 118 (for lot 28). Lot 27 is not a build-able lot and has no street address. The vacant lots north of the road have not been assigned street numbers. The lot addresses are from a numbering system for all waterfront properties on the lake.

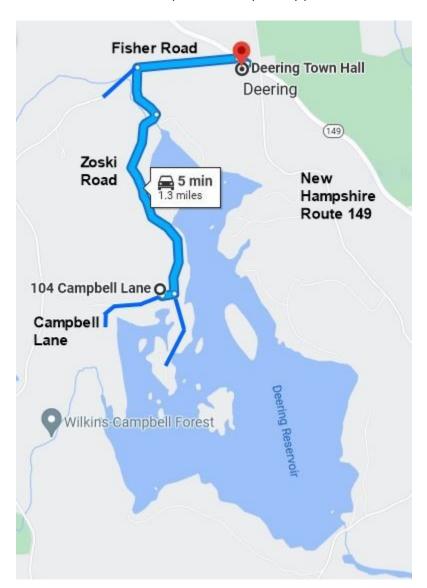
The route between Deering Town Hall and 104 Campbell Lane is shown below. The 3 roads involved are:

- Fisher Road
  - o A town-maintained paved road.
- Zoski Road
  - o A town-maintained gravel road.
- Campbell Lane
  - A private road, partially paved.

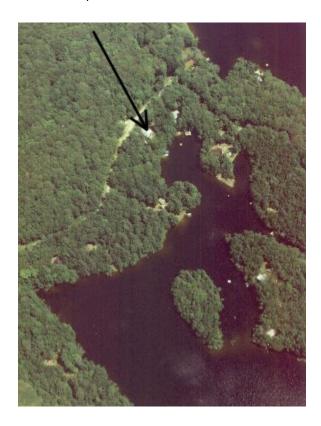
This is an aerial photograph that shows the upper end of Campbell Cove. The arrow points to 104 Campbell Lane. There is an island at bottom center; this is undeveloped, and cannot be built on under current zoning. This photo is:

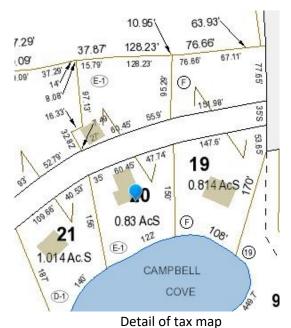
The lot at 104 Campbell Lane was defined as two tracts, together labeled as Lot E-1 on the Subdivision Plan referenced by the deed and shown above. The Zig-Zag line indicates the two tracts are part of the same lot. This is from tax map 229.

The south track will be called "The Waterfront Tract" and the tract north of the road will be called "The Rear Tract". They are separated by the Campbell Lane Right-of-Way.

The total lot size is 36,730 Square Feet or 0.843 Acres, per the subdivision plan. The boundary line adjustment included a land swap that did not change the lot size. It is estimated that the Waterfront (south) tract has an area of 0.440 acres, and the Rear (north) tract has the remaining 0.403 acres.

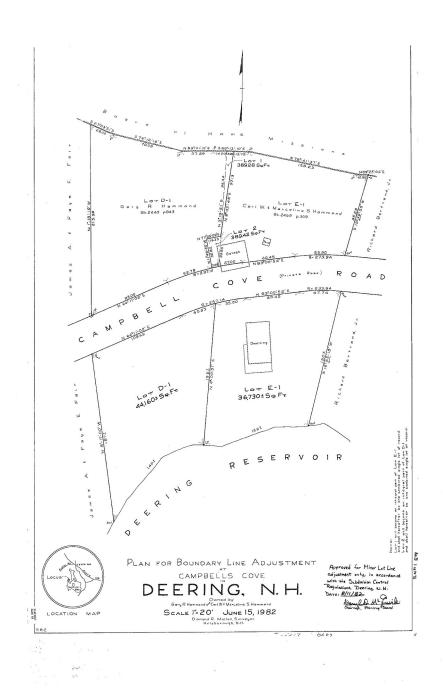
"Plan for Boundary Line Adjustment at Campbell's Cove in Deering, N.H." Dated June 15, 1982

In addition to the subdivision plan, the deed also references a minor Lot Line Adjustment where the same two tracts are together labeled as Lot E-1 on the drawing shown on the following page.

This Lot Line Adjustment was to address the situation where the garage had unintentionally been constructed in a position where it encroached on Lot D next door and the road. At that time Lot D was owned by the son of the owners of Lot E. The boundary adjustment swapped equal land area by jogging the new line around the garage in exchange for arriving at the stone wall at a new location. It was determined that a similar adjustment for the encroachment onto the road was impractical.

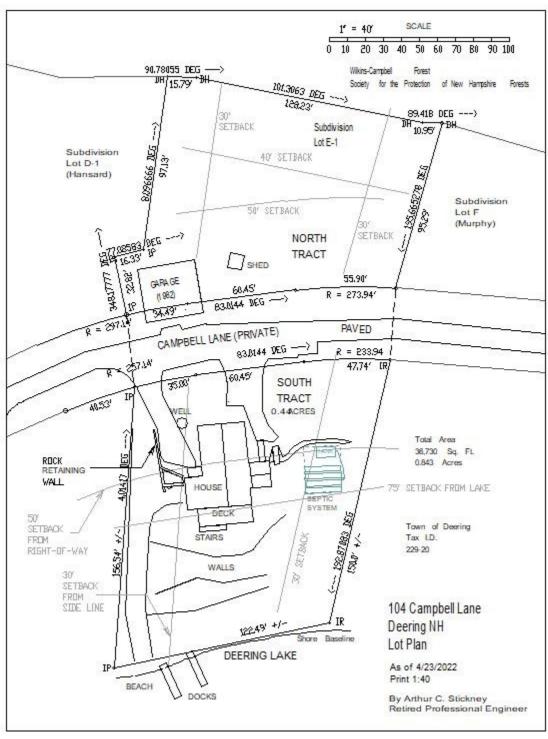
On the following page is a Lot Map made by the owner, who was a Registered Professional Engineer at the time. It is based on:

- The lot boundaries as defined on the subdivision plan.
- Locations of the corners, buildings and key features measured by the surveyor who
  designed the new septic system.
- Other measurements made by tape and corrected for elevation changes.

#### This plan shows:

- The two tracts of land, as defined on the lot adjustment drawing.
- The 40' wide road (right of way) between the tracts, and the road and driveway pavement of 1999.
- The private vehicle path going to the beach.
- The house, with the additions and ramp added in 1995.
- The garage and shed on the rear tract.
- The well and septic system location, including the underground septic tank, distribution box, and leach field.
- Major stone retaining walls and terraces.
- The approximate shoreline, which is the Shore Baseline, and the Sand Beach.
- The two 4' x 20' permanent docks.
- Setbacks required by the Town's Zoning.

The Waterfront Baseline is not accurately shown on the plans. The iron pins marking the lot corners are set back a few feet along the side lines from the baseline to minimize being disturbed or lost. The baseline can be difficult to survey because the rocky shoreline is far from straight and changes over time.

The house foundation on this lot has a 75' setback and the deck and its stairs have a setback of at least 63.6' from the Baseline. The required setback when the deck was built was 50'.

The house encroaches into the 50' setback from the road required by Zoning. The original house was built about 1978, before Deering had a Zoning Ordnance or setback requirements. The two additions built about 1994 were within the setbacks required by the Zoning then in effect.

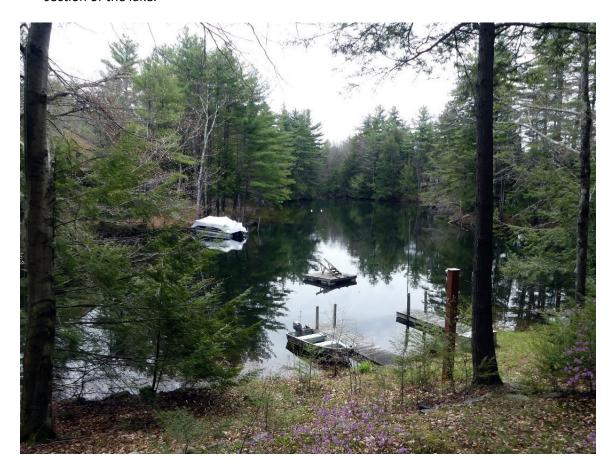
This photo was taken from in front of the house in early spring. It shows the property's two docks, light pole, and swimming float. The beach area is at extreme right.

The property has a pair of permanent wooden docks, both  $4' \times 20'$ . These are made of pressure treated wood and are anchored by buried beams. They were rebuilt in the mid 1980s. The western dock has a flag pole.

There is a pole near the docks that provide lighting, an outlet, and a telephone jack. Wiring is underground from the house and lighting can be controlled from the waterfront or house. There are a set of pole lamps to light the path from house to waterfront.

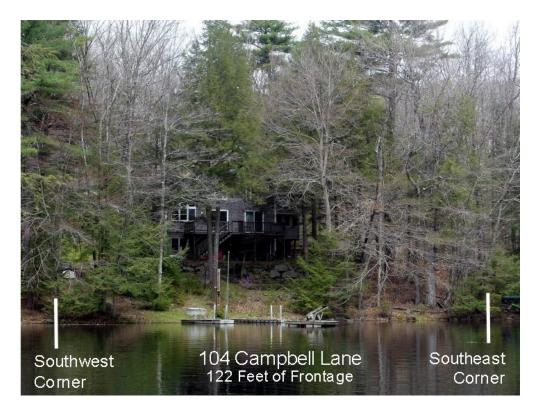
This annotated photo shows the lot's entire 122 foot lake frontage looking from the water toward the house. The beach is to the left of the docks. A foot path with rock steps runs from the docks to the stairs for the deck. A vehicle path runs from the beach to the road. The eastern half of the waterfront is undeveloped woods.

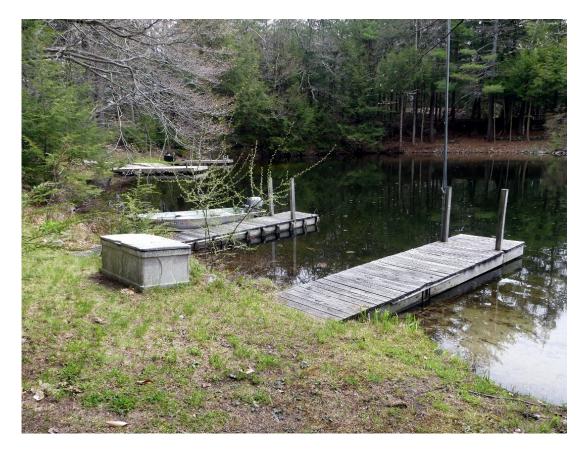
The sand beach, mostly underwater, is to the right of the docks. The area at the bottom is sand.

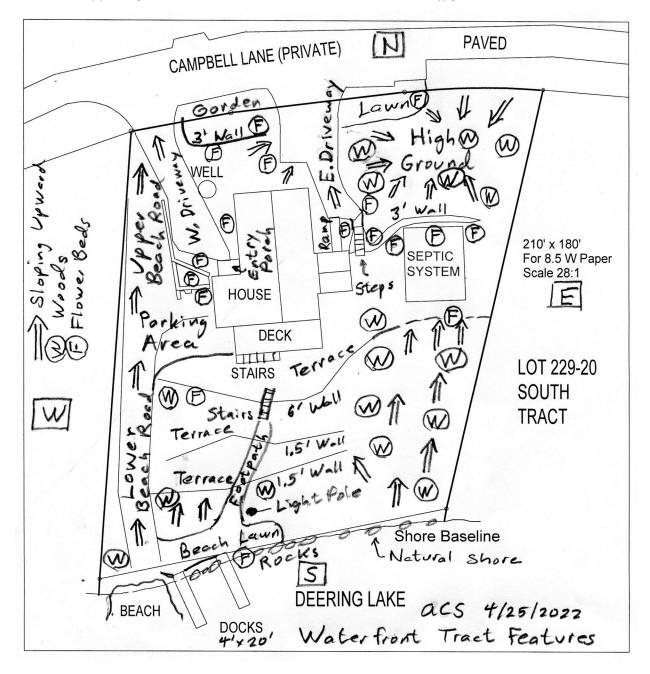
This sketch shows the Waterfront Tract's topography and features. Arrows point uphill. ["Supporting Documents/3471 Front Tract Features 2022 4 25.jpg"]

The west side has been graded and filled to create a beach assess road, which climbs steadily about 29' in the 170' distance from beach to road. This has a solid gravel base alongside the house, suitable to be an all-season vehicle driveway. This allows vehicle to park and turn around at the level of the walk-out basement. Near the beach the road has loose sand.

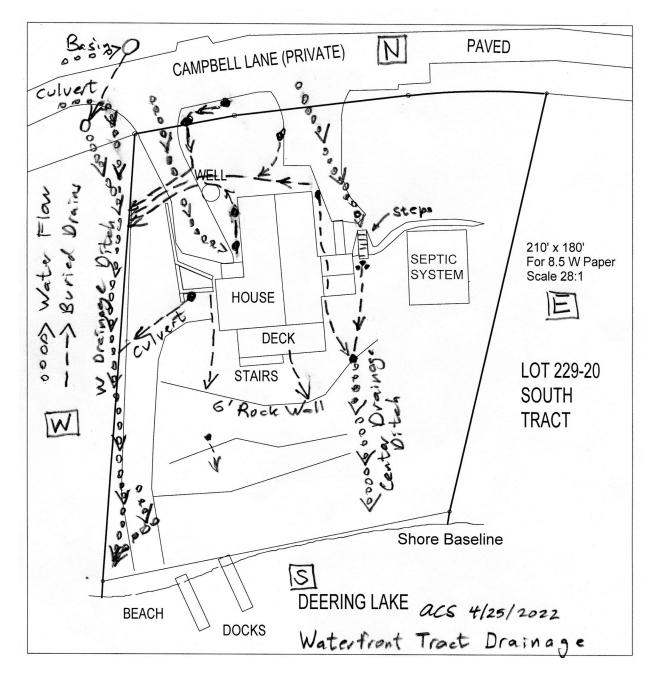
This shows the primary drainage for the Waterfront Tract. ["Supporting Documents/3473 Front Tract Drainage 2022 4 25.jpg"]

- All water entering the Waterfront Tract comes across Campbell Lane.
- Water coming from the lot next door goes into the West Drainage Ditch.
- In extreme conditions some water from the Rear Tract Brook crosses the road.

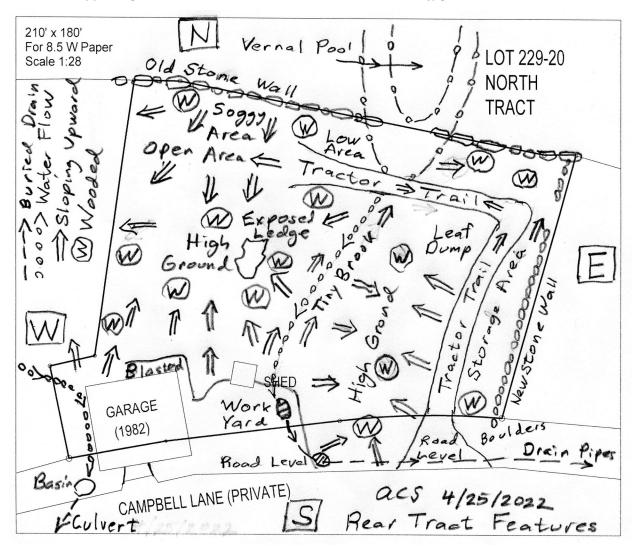
This figure shows the rear tract's topography, features, and drainage:

Double-line arrows point uphill.

Arrows with small circles show surface water flow.

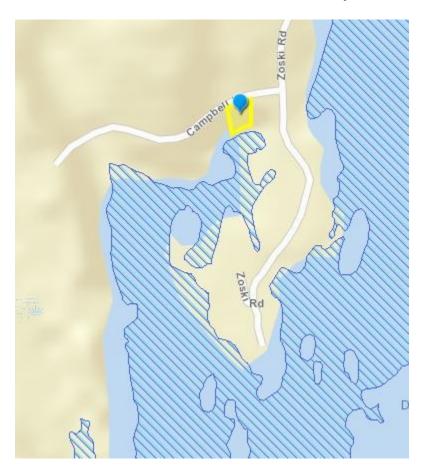
The following figure shows an extract from the official flood map for the immediate neighborhood. This comes from from the Town's GIS mapping.

Flood map for neighborhood captured from Town of Deering GIS website.

The lot abuts the Lake, which is a Designated Flood Hazard Zone. This zone involves only the immediate shoreline with the docks and beach. The lot rises quickly away from the lake and is no longer in the Flood Zone. The basement floor is located about 18' above the lake. The dam would fail and drain the lake before the water level could get that high. The highest lake level observed in 39 years has been about a foot over normal high water.
