**Addendum to Property Disclosure  
For 104 Campbell Lane, Deering New Hampshire**

This is an Addendum to the "0406 Property Disclosure...." document for the Property. It provides additional detailed information not typically provided in a Disclosure. It is a supplement to the Disclosure. It has been prepared by the Seller. This does not have all sections of the standard Disclosure. Items that are completely covered on the Disclosure may be omitted here.

**2. PROPERTY LOCATION:** 104 Campbell Lane, Deering NH 03244

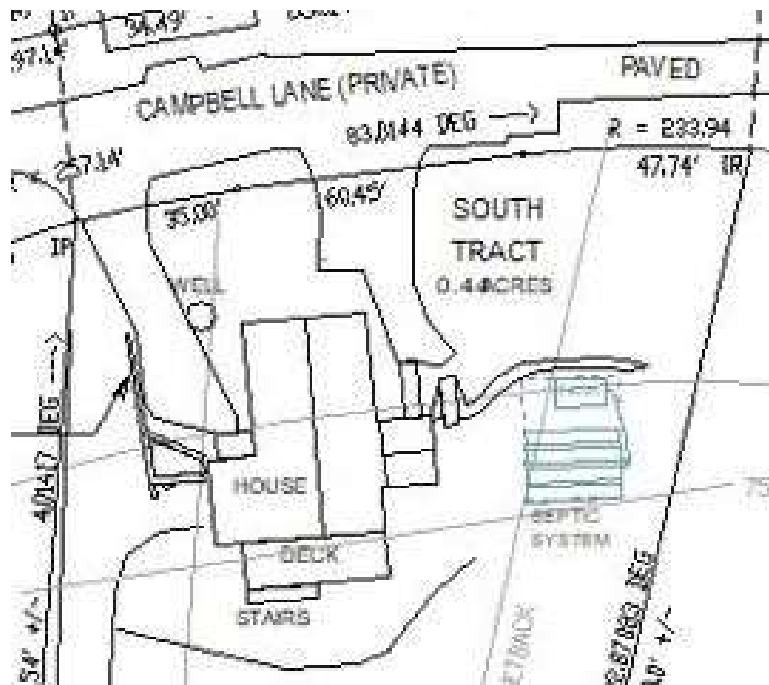
**5. & 6. – Location of Well and Septic System**

This plan shows the location of the house, well and septic system.

The 8" diameter well was drilled in 1978, when the house was built. The location is shown in the figure above. It goes down about 389' into bedrock (measured during pump replacement). There is a steel casing down to the bedrock. It an Artesian Well, with static level about 20' down. A large water supply was encountered at the bottom. The flow was reported by the original owner to be too great to measure. A submersible pump is located 250' down into the well. The original installer is unknown.

The location and configuration are shown in the proceeding figure. The house originally had a 2-bedroom system, installed in 1978. This was completely replaced by a larger 4-bedroom Septic System, installed in 1994, preceding the house expansion. It has a 1500 gallon concrete septic tank, which is larger than the 1250 gallon tank required for a house with 4 bedrooms and 28 or less plumbing fixtures. (The house has 21 fixtures, including 2 washing machines and a dishwasher).

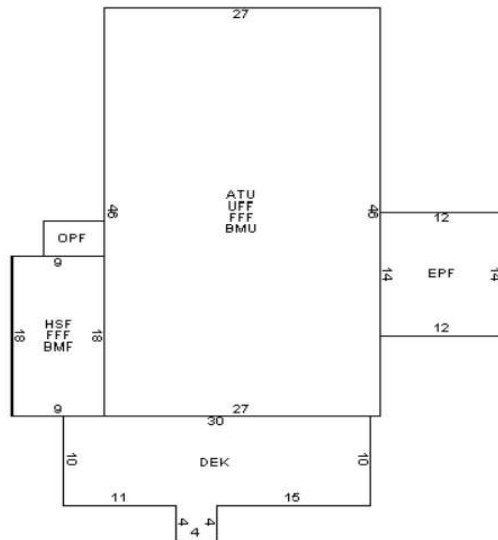
### Town Assessing Information

BUILDING SUB AREA DETAILS				
ID	Description	Area	Adj.	Effect.
HSF	1/2 STRY FIN	162	0.50	81
UFF	UPPER FLR FIN	1242	1.00	1242
OPF	OPEN PORCH	24	0.25	6
FFF	FST FLR FIN	1404	1.00	1404
BMF	BSMNT FINISHED	162	0.30	49
DEK	DECK/ENTRANCE	316	0.10	32
ATU	ATTIC	1242	0.10	124
BMU	BSMNT	1242	0.15	186
EPF	ENCLOSED	168	0.70	118
<b>GLA:</b>	<b>2,727</b>	<b>5,962</b>		<b>3,242</b>

Above is information from the town assessing card. The drawing was used in the calculations above.

The “GLA” value above is an adjusted area intended for use in determining house value. Area sub-values were adjusted for condition as viewed about 20 years ago, before much of the interior finishing was complete. The value does not reflect current condition. The deck and other unenclosed areas are included in their table.
